BSD-135: Ice Dams

By John Straube

Created: 2006/10/30

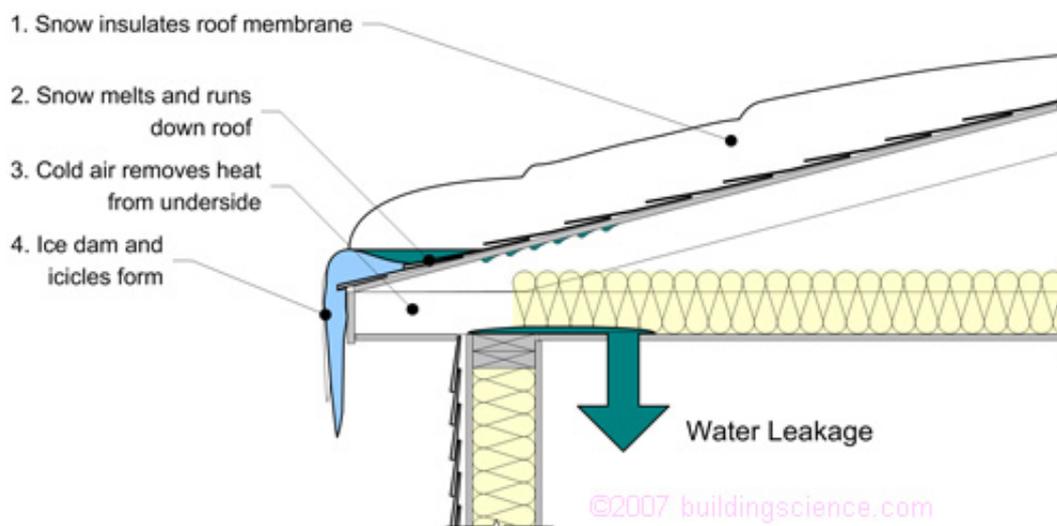
Figure 1: Ice dam at a typical roof.

Simply put, ice dams are ridges of ice and icicles caused by meltwater from further up the roof re-freezing lower on the roof. The “dam” created by the ridge of ice along the eaves can trap further meltwater and result in significant leakage under and through the roofing, especially shingles and metal roofing. This leakage can cause damage to the sheathing, the roof structure, or the ceiling and walls below. Large icicles along the eaves can become a danger to people below if they fall.

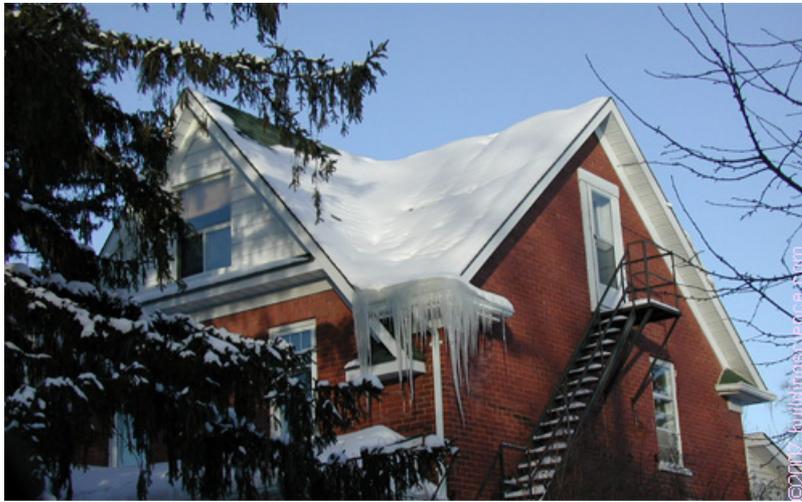
Photograph 1: An ice dam; note the snow melting on the slope above the ice dam.

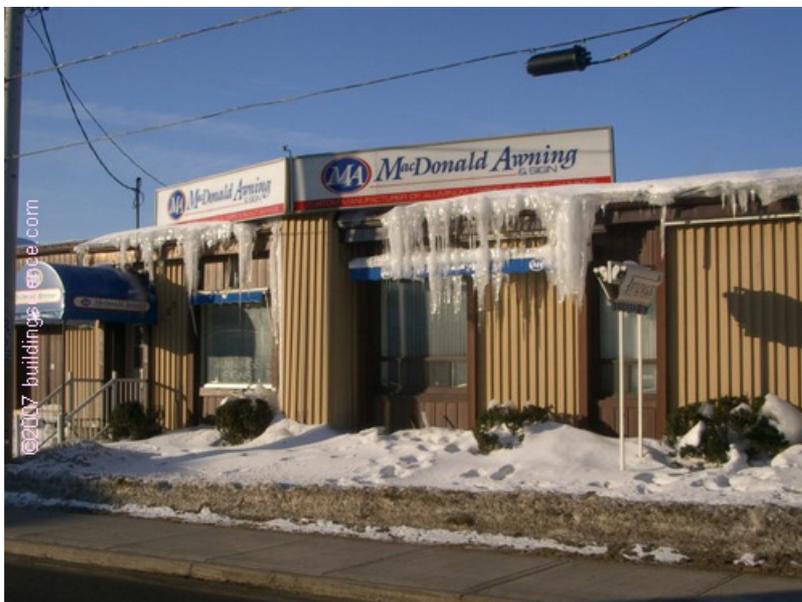
Photograph 2: Not just a problem for sloped roofs.

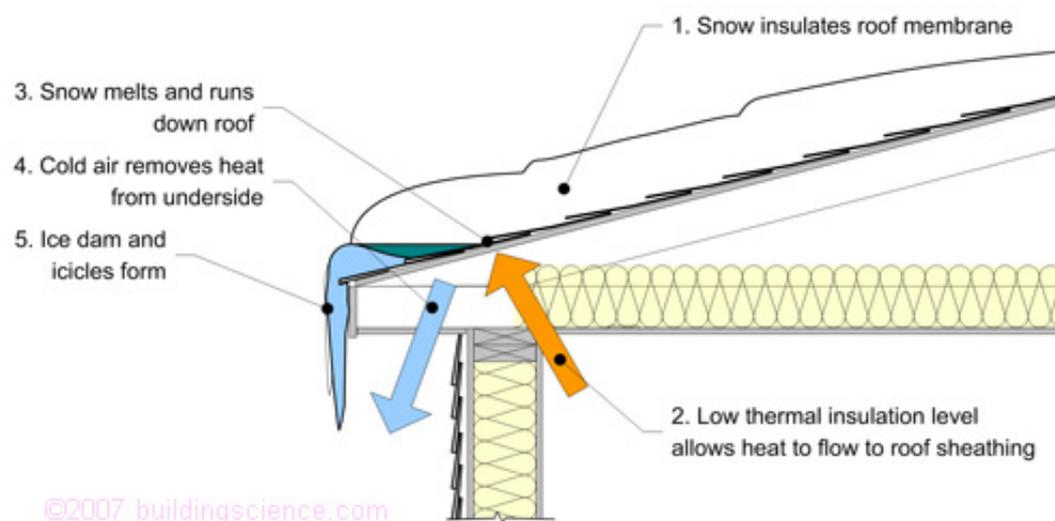
Figure 2: The process of ice dam formation caused by poor insulation.

If there is insufficient insulation between heated space and the roof sheathing, significant amounts of heat can flow to the underside of the sheathing. Snow also insulates the roof membrane, increasing its temperature. This scenario will raise the temperature of the roof-snow interface above the melting point even at cold outdoor temperatures. The result is many hours of snow melting with sufficiently low temperatures to ensure rapid freezing (**Figure 2**).

The greater the snow depth on a roof (which is a function of the snowfall, the slope and friction of the roof, and the weather elements that encourage evaporation), the more its insulating effect on the roof membrane. For the same amount of insulation on the inside, an increase in snow depth will increase the temperature at the interface between the snow and the roof. Once enough snow has been accumulated, melting will begin. Once the meltwater reaches the eaves, the heat loss from the underside of the eaves and the fascia ensures that the water refreezes. Even when enough insulation is specified, problems arise where heat flow through large framing members and compressed insulation at truss heels results in lower installed R-values.

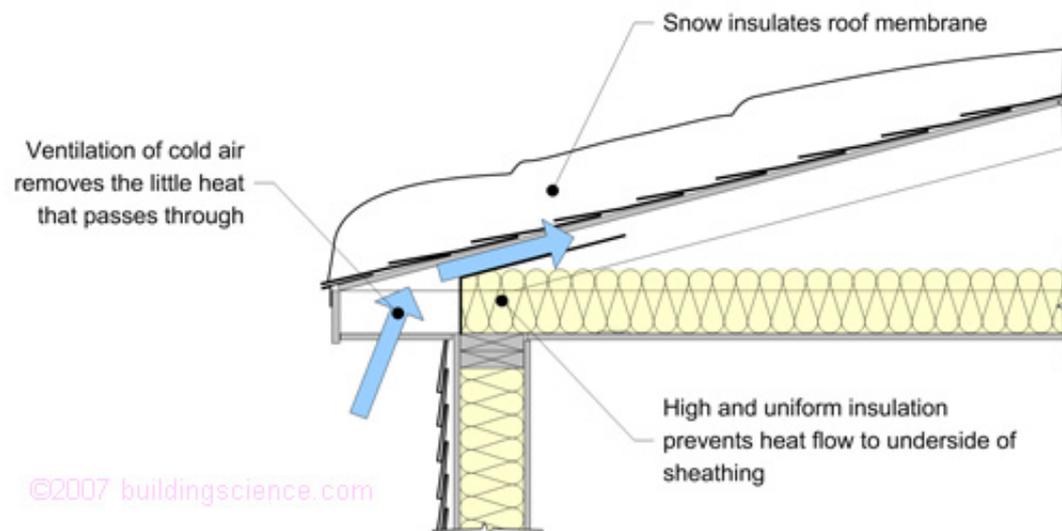
Figure 3: Solutions to poor insulation.

Another way to keep the sheathing cold is to ventilate with outdoor air (**Figure 3**). Although ventilation will remove some of the heat that passes through the ceiling, very low levels of insulation and thermal bridging cannot practically be offset by ventilation. Ventilation is best used as a supplement to good insulation as ventilation can be used to remove the little heat that flows through a well insulated roof.

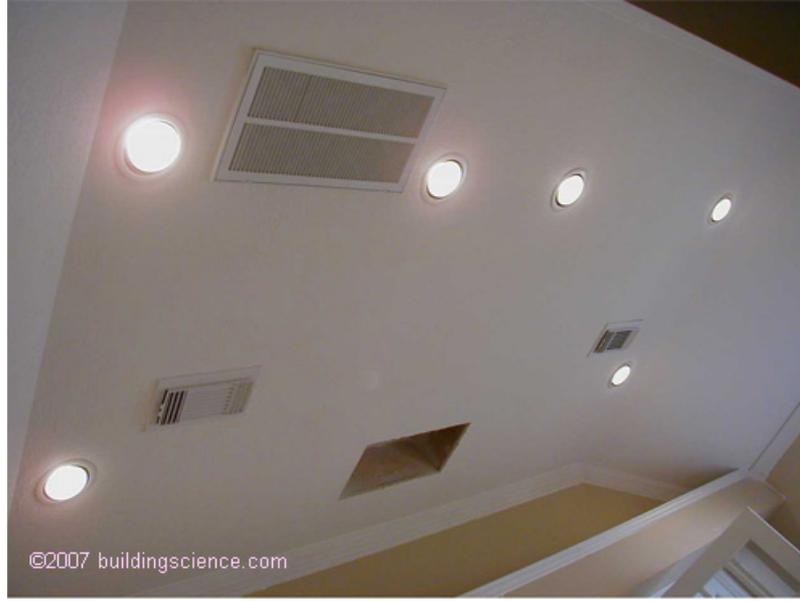
Photograph 3: Ceiling penetrations in a cathedral ceiling.

Plumbing stacks, recessed lights, chimneys, electrical service penetrations in partition walls, and attic hatches all can on their own, or in combination, allow sufficient air leakage into the ceiling space (cathedral or attic) to cause serious condensation and ice damming problems (**Photograph 3**).

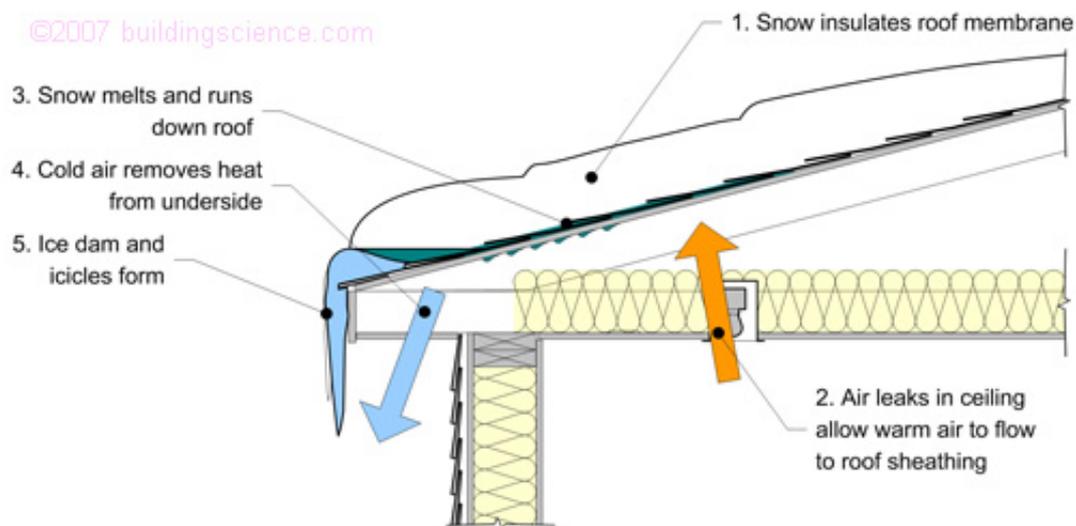
Figure 4: Ice dam formation process caused by air leakage.

Not only does air leakage into the roof cause warming and melting of snow, in colder weather it often causes condensation on the underside of the roof sheathing. The two processes combined can cause serious wetting and decay of the sheathing and roof structure as well as leakage into the space below (**Figure 4**).

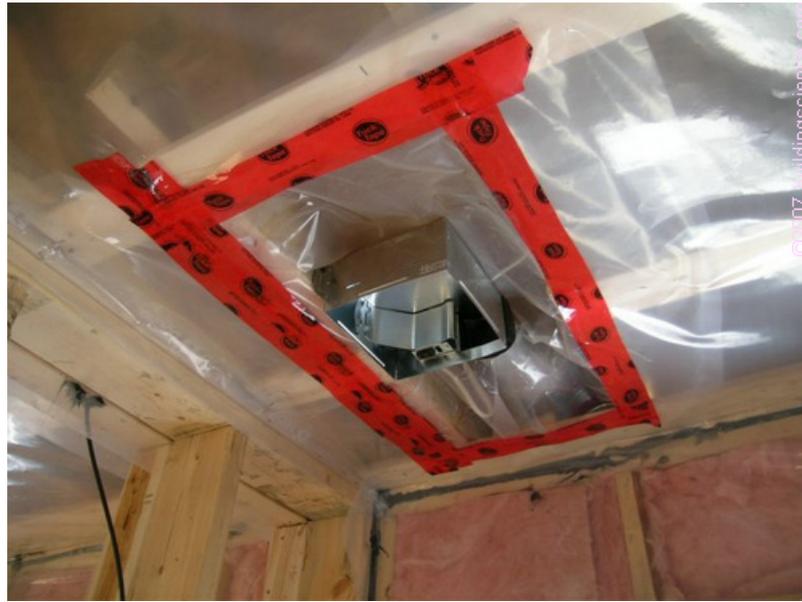
Photograph 4: Polyethylene sheet sealed as air barrier around bathroom fan housing.

Although the solution is rather simple to state, it is quite difficult to achieve in practice. Great care must be taken to seal the ceiling air barrier (often the polyethylene vapor barrier is used as an air barrier or the drywall; see **Photograph 4**). **Table 1** provides a list of air leakage locations and means to ensure they are sealed.

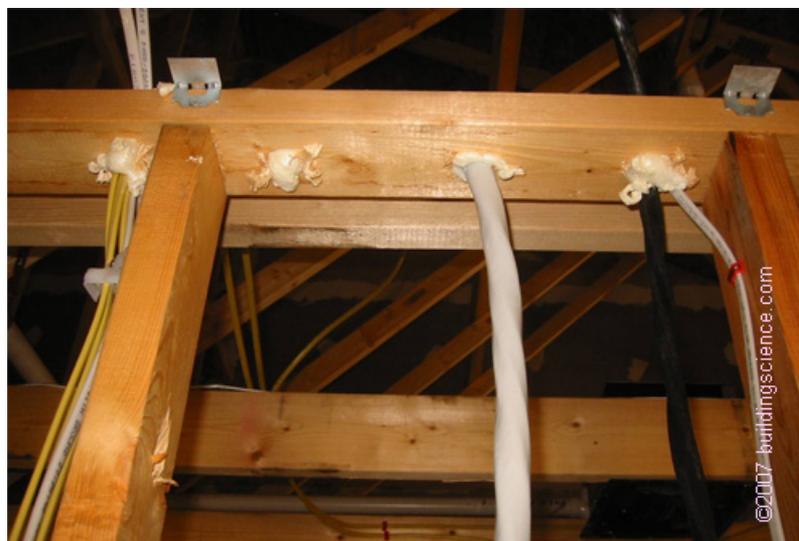
Photograph 5: Air-sealing with expanding polyurethane foam – much easier to do before the interior finishes are installed.

Caulking can be used around small openings and gaps, but expanding polyurethane or acrylic foam should be used around openings more than about 1" (see **Photograph 5**). For large openings, drywall can be used as the air barrier with taped or caulked joints used to complete the seal. Great care and attention to detail is essentially the only solution to air leakage, although expensive answers such as spraying the entire ceiling with expanding foam (NOT dense-pack cellulose, or blown in batts) can provide the required airtightness quite

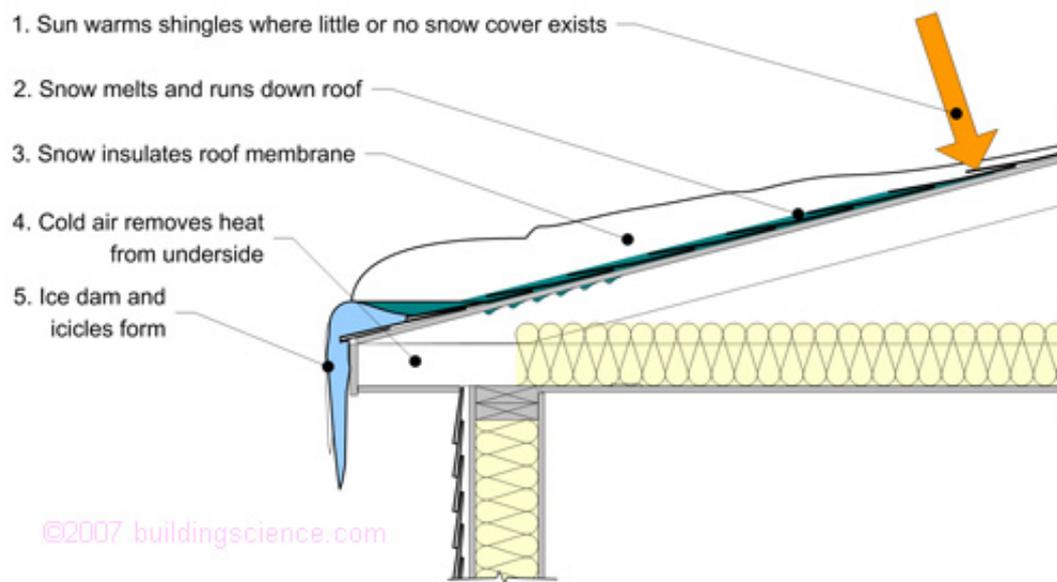
Figure 5: Ice dam formation process due to uneven snow thickness.

Wind speeds are often higher near ridge lines and scour snow from the roof. Snow catchers at the base of metal roofs hold back sliding snow near the eaves. Exposed shingles or metal can easily be heated to 70 F (40 C) above ambient air temperature and cause melting of the snow immediately next to the exposed roofing. Water will run down the roof and can freeze at the eave, which is cooled from the underside (**Figure 5**). If the temperature is cold enough and the snowcover thin enough the meltwater may form a relatively harmless thin sheet of ice below the snow. In other situations, large ice dams and icicles can form.

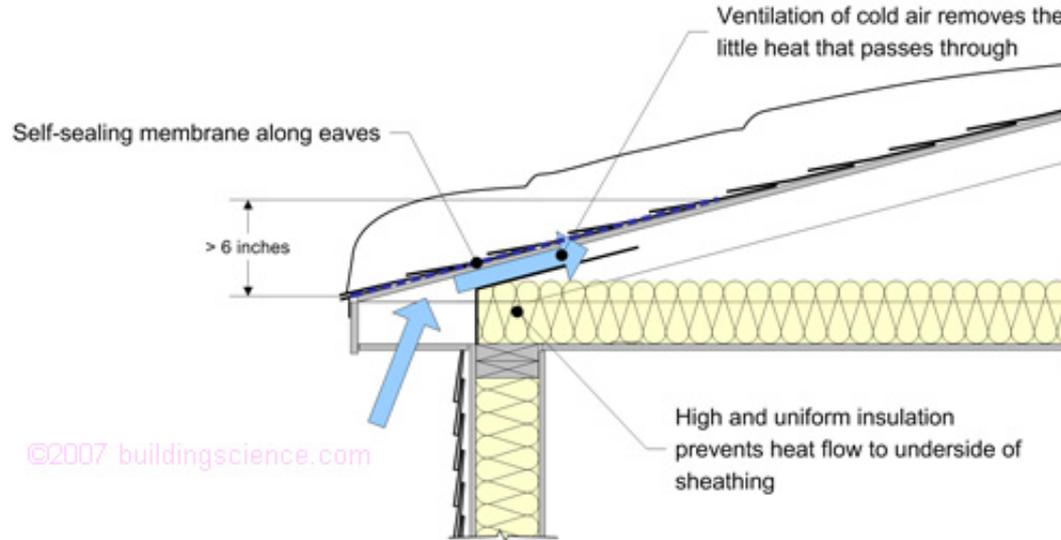
Figure 6: Waterproof “eaves-starter” or “peel and stick.”

Keeping the underside of the roof sheathing close to the exterior temperature is the best solution. This can be achieved with good ventilation and good insulation acting in concert. Even if all good design practises are followed this process can still occur. For this reason it is recommended that a waterproof membrane (preferably self-sealing to accommodate roofing nails) be provided. This membrane should come up the roof high enough to resist a 6 to 8" height of water above the edge of the wall insulation below (**Figure 6**). Hence, steep pitched roofs will require narrower strips of this membrane than shallow roofs.

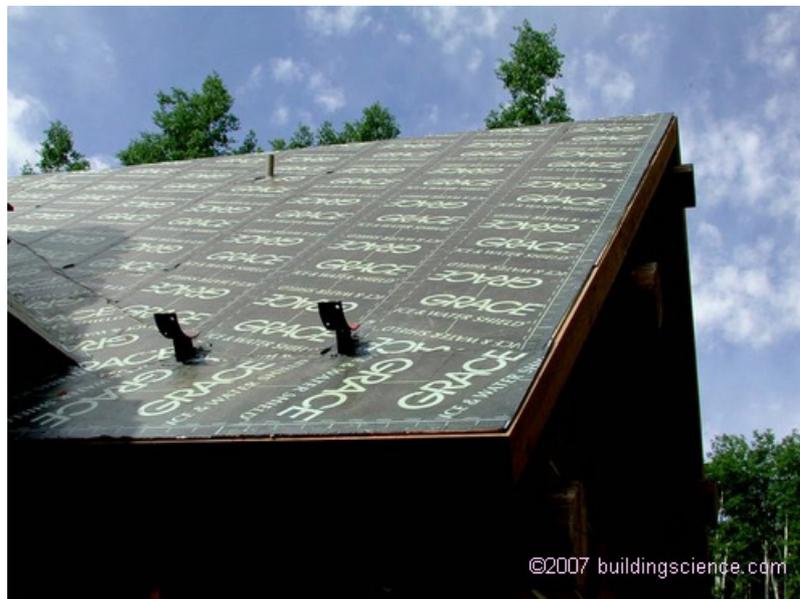
Photograph 6: Self-adhering membrane over the entire roof surface – an appropriate solution in some climates.
